## Coating Health Monitor (CHM)

### *Background*

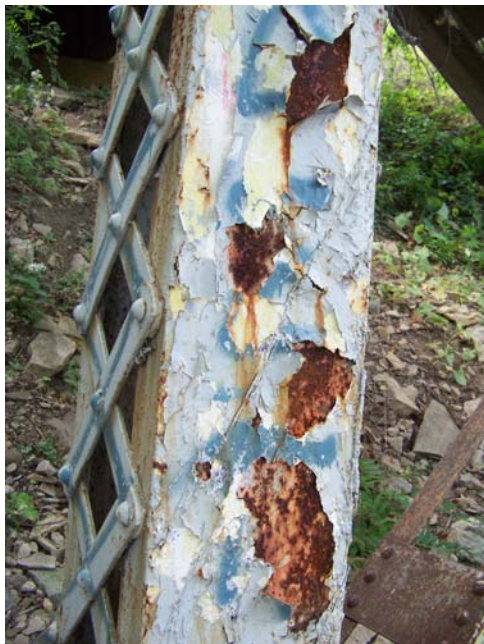
*Figure 1. Corroding support of a railroad bridge.*

Paint coatings are the primary means of corrosion protection for most structures and they can be very effective. However, paint coatings are only temporary; they weather, absorb moisture, blister, become scratched or undergo other mechanical damage (Figure 1). Even fresh paint coatings can exhibit pinholes, holidays, or other coating defects that can adversely affect corrosion protection. Thus, there is a need for corrosion sensors to assess the health and effectiveness of paint coatings, especially on critical structures and equipment.

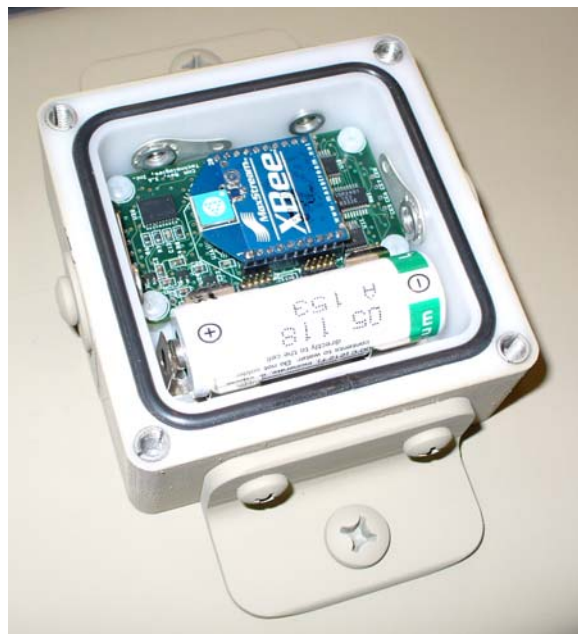
Figure 3. CHM with top removed.

The CHM system consists of one or more sensor electrodes, a mini-potentiostat, nonvolatile memory, a wireless data transmitter, and a battery power source. It can be linked wirelessly to the control system or a computer. The CHM is sealed in a housing (except for the sensing elements) to protect the electronics from corrosion (Figure 3). The size, the wireless aspect and the low-cost are some of the attractive features of the sensor. Specifically, the CHM

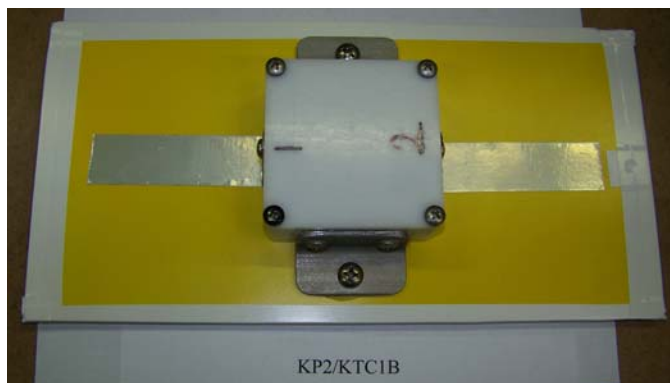
Figure 4. Painted panel with mounted CHM and tape electrodes.

To demonstrate the CHM, several panels, covered with different paint coatings (Figure 4) were tested in the laboratory and coating degradation was tracked by the CHM. Accelerated corrosion exposure was achieved with alternate immersion (10 minutes immersion and 50 minutes atmosphere) in 3.5% NaCl solution (ASTM G44) as shown in Figure 5. The CHM was programmed and interrogated from a laptop computer in an office 40-50 feet (~15 meters) away.

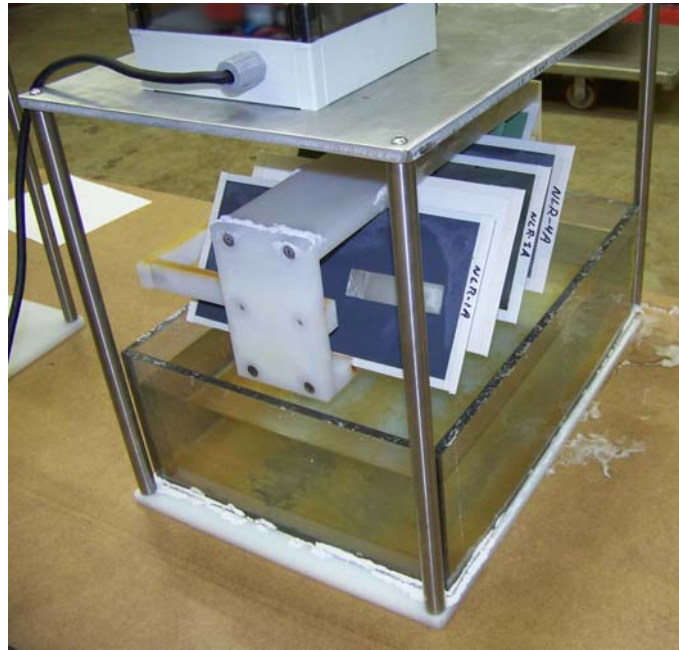
Figure 5. Panels in alternate immersion testing.

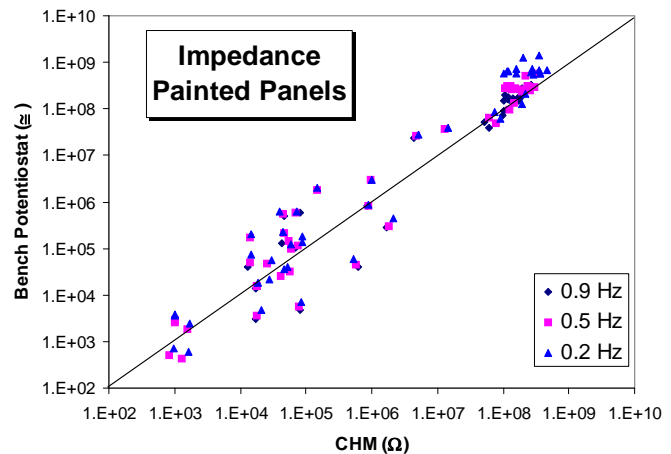
Figure 6 is a log-log plot comparing the impedance measured by a CHM (x-axis) and a bench top potentiostat (y-axis) for several paint coatings undergoing laboratory alternate immersion testing. The plot shows a strong positive correlation between the two measurement methods, with data points for three different frequencies (0.9 Hz, 0.5 Hz, and 0.2 Hz) clustered around a diagonal line representing a 1:1 ratio. The impedance values range from  $10^2 \Omega$  to  $10^{10} \Omega$ .

Figure 6. Comparison of results CHM and bench-top potentiostat for several paint coatings undergoing laboratory alternate immersion testing.

To verify the accuracy of the CHM, comparisons were made using a commercial Gamry bench top potentiostat. The EIS measurements for the CHM and Gamry potentiostat exhibit excellent agreement over six orders of magnitude (Figure 6) for all three frequencies measured by the CHM. To put this in perspective, a good coating system would typically exhibit an impedance of  $10^8 \Omega$  or higher while a poor coating system that no longer provides a barrier to the environment would typically exhibit an impedance of  $10^6 \Omega$  or lower.

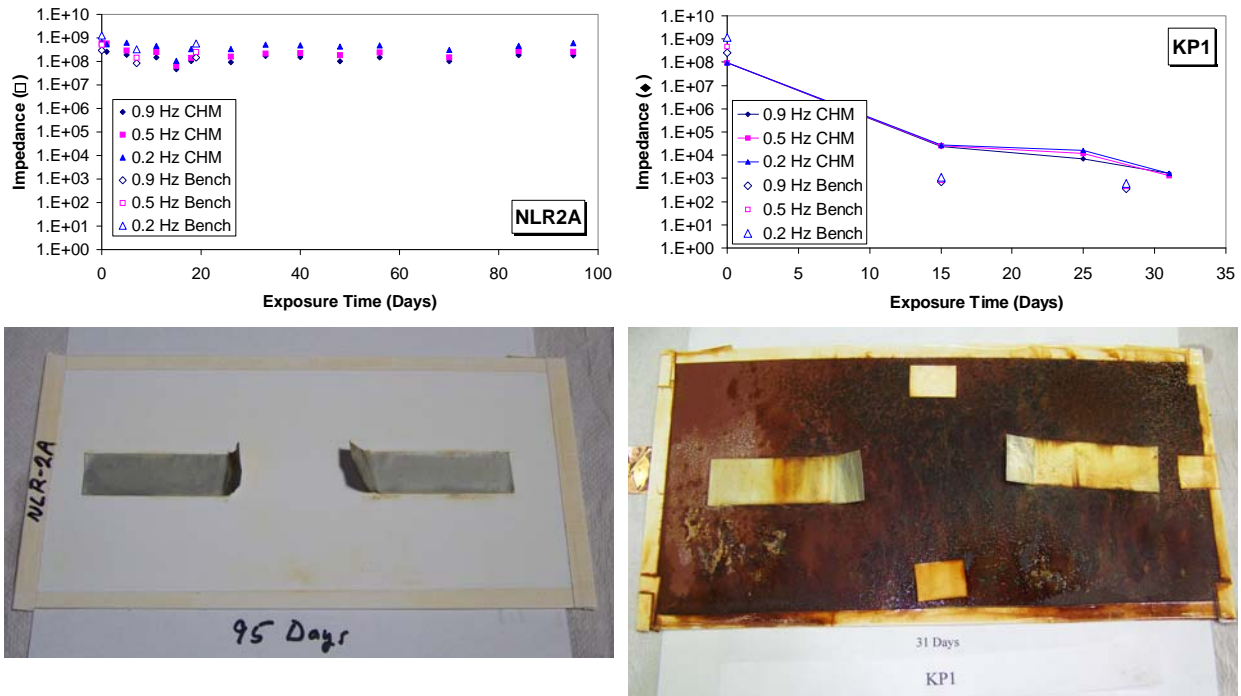
Figure 7. Examples of a good coating (left) and a poor coating (right). The good coating exhibits high electrochemical impedance with almost no change and no corrosion after 95 days. The poor coating exhibits a significant decrease in electrochemical impedance at the first measurement following commencement of testing and extensive corrosion after 31 days. The solid points are the CHM results. The open points are Gamry bench top results.

Examples of coatings with good and poor performance are given in Figure 7. The good coating exhibits high electrochemical impedance with very little change during the testing period. No corrosion can be seen after 36 days of testing. In contrast, although the poor coating exhibited high electrochemical impedance before testing, its impedance had dropped by three to four orders of magnitude by the first measurement period. A further check on the condition of the coating is the impedance dispersion for the three frequencies. For the good coating, the impedances remain distinct, indicating that the low-frequency impedance spectrum has capacitive behavior. (That is, the Bode log-log plot of impedance vs frequency has a negative slope as shown in Figure 2.) For the poor coating, three impedances are nearly identical, indicating resistive behavior. (That is, the Bode plot has a near zero slope also as shown in Figure 2.) Both the CHM and Gamry bench top measurements give similar results.

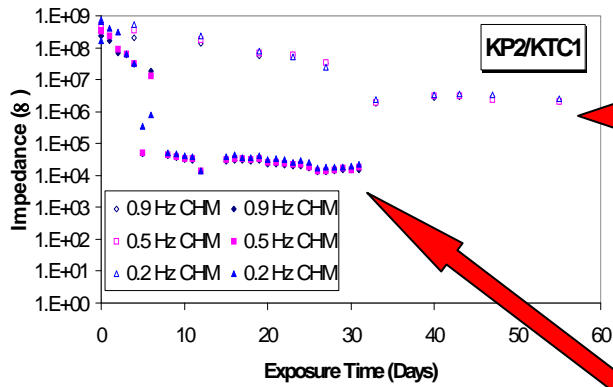
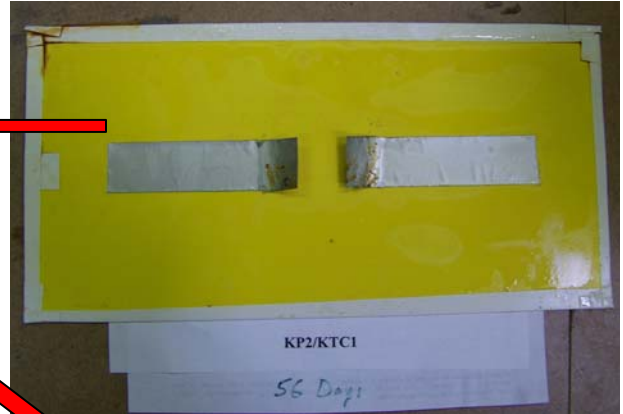
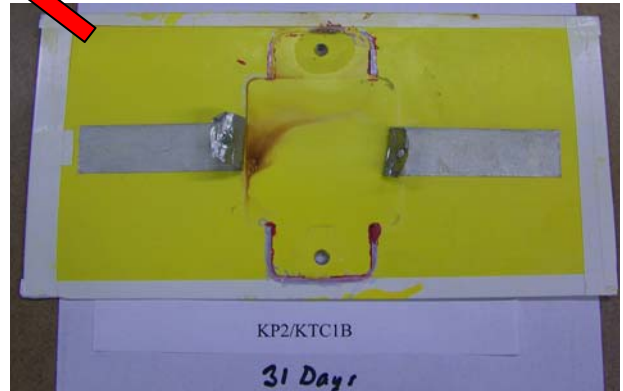
Figure 8. CHM EIS results of two nominally identical panels. One panel (top curve) exhibited a slow decrease in impedance. After 56 days, the panel (upper right) showed no corrosion except at one corner near or under the tape along the panel edge. The other panel (lower curve) exhibited a more rapid decrease in impedance. After 31 days, the panel (right) showed corrosion underneath the mounted CHM.

In a few cases, duplicate painted panels were prepared. In one case, a CHM was mounted on one panel while a nominally identical panel was tested using a free CHM. The two panels exhibited very different EIS behavior during testing (Figure 8) with one exhibiting a slow decrease in impedance and the other exhibiting a much more rapid decrease in impedance of four to five orders of magni-

tude. At the end of its test (56 days), the first panel had no corrosion except at or near one corner. This corrosion appeared to originate under the tape that was intended to protect the panel edge where coating defects often occur. The second panel had a mounted CHM unit during testing. Once the CHM was removed after 31 days, corrosion was apparent that had begun at a coating defect underneath the CHM module. Here the CHM detected this defect very shortly after the alternate immersion testing began.

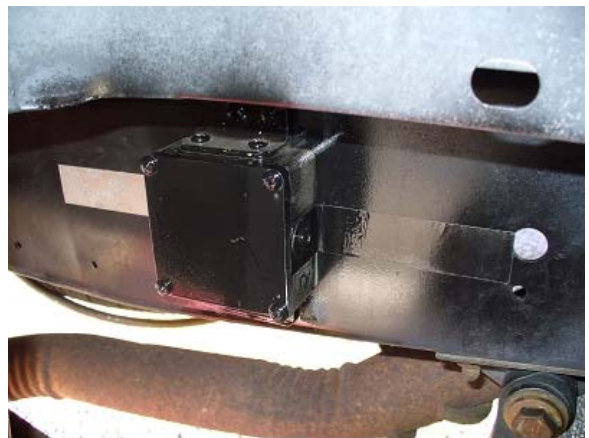
Figure 9. CHM mounted on the frame in a wheel well of a pick-up truck.

Another CHM was mounted on the frame of a pick-up truck (Figure 9). Measurements were successfully obtained over a period of several months from the truck-mounted CHM using a computer in an office across from the parking lot.

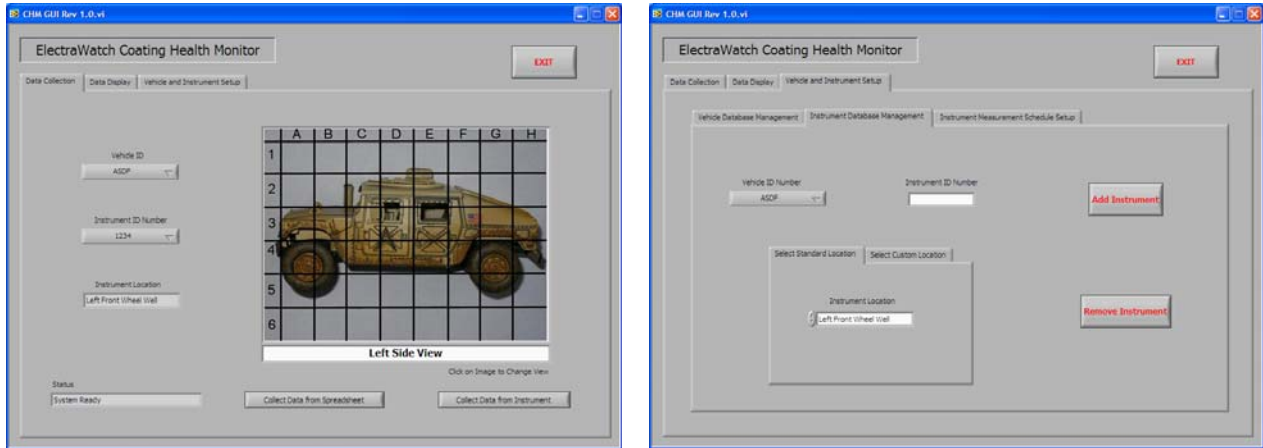
Figure 10. Different screen views of GUI.

To allow the CHM measurements to be accessed and interpreted by a technician or inspector, a Graphic User Interface (GUI) was developed and is being modified based on user feedback. Figure 10 shows three screen views of the CHM GUI. The top screen allows the inspector to interrogate individual CHMs. Upon receiving this command, the CHM will transmit its stored readings to the inspector. The middle screen allows the inspector to enter identifying information about the vehicle, CHM, and the location of the CHM. The bottom screen allows the inspector to set the frequency and time for each CHM to take measurements. For example, the CHM can be set to take measurements hourly, daily, weekly, or monthly.

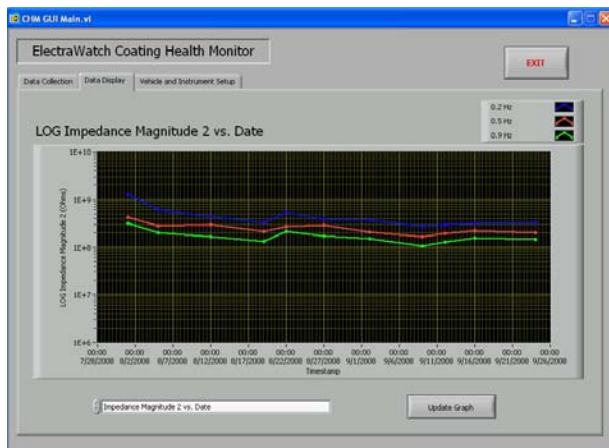
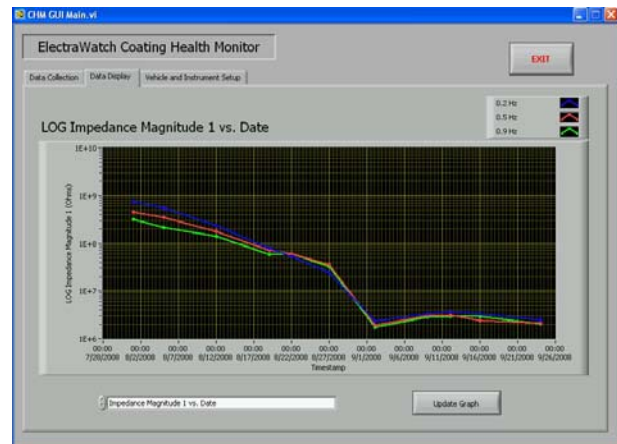
Figure 11 CHM GUI screen shots showing a good coating (left) and one that is degrading (right). Note the differences in impedance scale.

A display screen (Figure 11) then allows the electrochemical impedance to be displayed so the inspector can determine the coating health and its rate of change. Results from two coatings are shown. The good coating exhibits little change in the electrochemical impedance while the poorer coating exhibits a decrease in its electrochemical impedance of two orders of magnitude.
